Report to Ranking Member, Committee
on Homeland Security and
Governmental Affairs, U.S. Senate

March 2016

FEDERAL REAL PROPERTY

GSA Could Better Identify Risks of Unforeseen Conditions in Repair and Alteration Projects

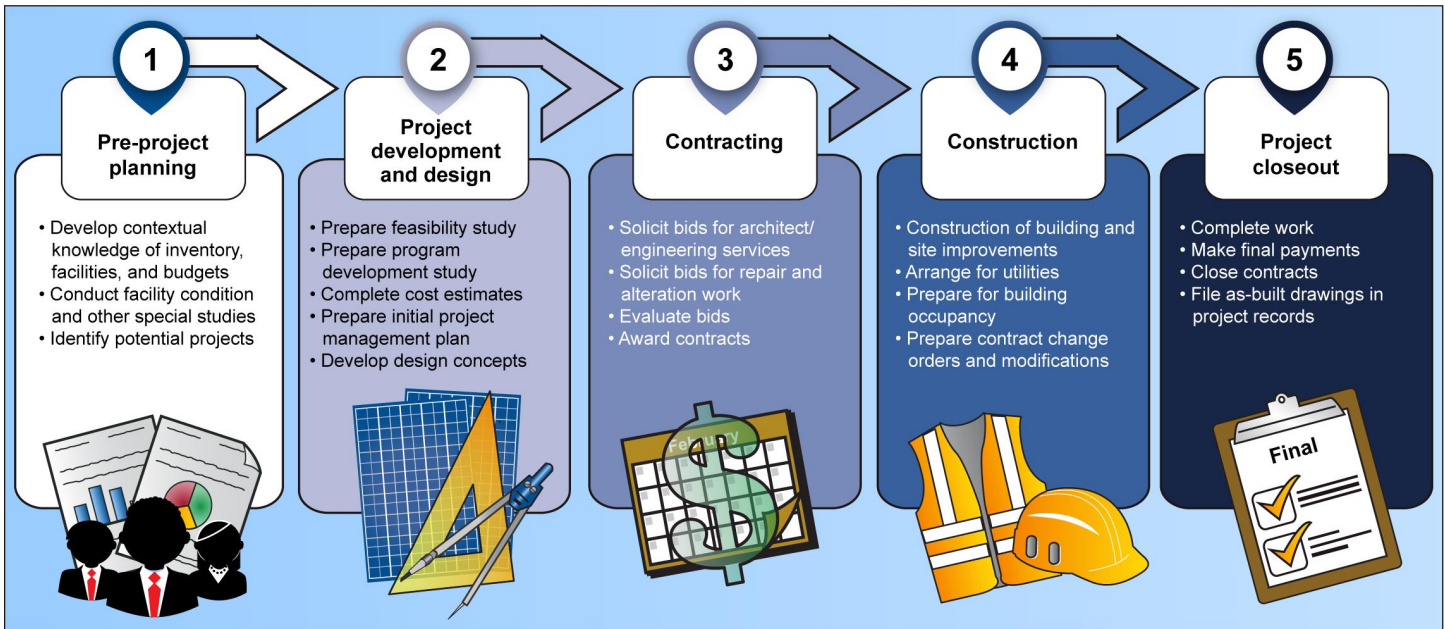
Figure 1: Phases and Selected Activities in the General Services Administration’s Planning and Execution of Repair and Alteration Projects

The following briefly describes these five phases:

- **Pre-project planning:** According to GSA’s *Project Planning Guide*,²¹ the pre-project planning phase is where GSA develops the contextual knowledge of its inventory, facilities, budgets, and stakeholders. This is to enable GSA to identify potential projects, alternative solutions, and implementation strategies. Among other things, this phase would include facility condition and other special studies to assess the condition of GSA’s inventory and identify repair and alteration needs.

- **Project development and design:** This phase is where GSA begins to develop a repair and alteration project in more detail, to refine options, and to develop project management plans (PMP). According to GSA officials, project development also includes risk assessment, including documentation of known and likely unknown conditions. GSA’s *Project Planning Guide* indicates both a feasibility study, which

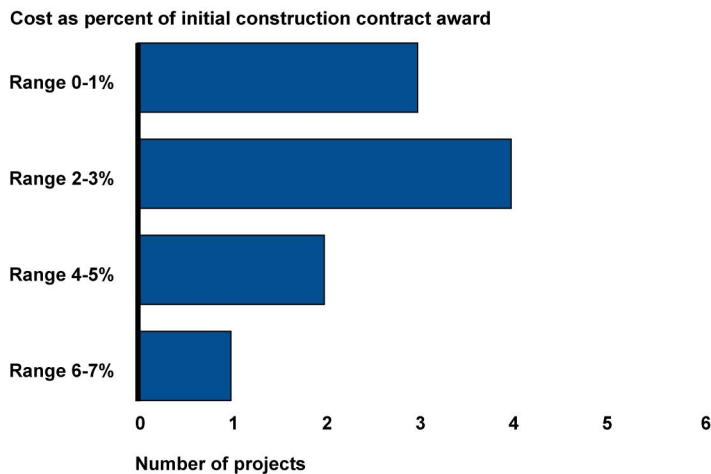
Figure 2: Cost Increases from Unforeseen Site Conditions on the General Services Administration's Repair and Alteration Projects GAO Reviewed

Note: For the repair and alteration project at the Daniel P. Moynihan Courthouse, the total cost for addressing unforeseen site conditions, about \$318,000, includes an item with a cost of \$20,500 that addresses both work on an unforeseen site condition as well as work unrelated to unforeseen conditions. Also, we did not include a cost for the unforeseen site condition encountered during the project at the U.S. Secret Service's firing range because there was no contract modification associated with the unforeseen site condition and the cost of the unforeseen site condition was unknown.

However, despite the prevalence of unforeseen site conditions in our selected projects, our review showed that the overall impact of these conditions appeared largely limited. On nine of the 11 projects we selected that experienced unforeseen site conditions, the cost for remediating those conditions accounted for 1 to 5 percent of the project's original construction contract award (see fig. 2).²⁶ On one of the 11 projects—a prospectus project to, among other things, modernize the heating, ventilation, and air-conditioning system at the New Executive Office Building in Washington, D.C.—the cost for addressing unforeseen site conditions was approximately 6 percent of the original construction

contract award.²⁷ All of the reported costs for remediating unforeseen site conditions on the projects we reviewed were below the typical 10 percent construction contingency that GSA attaches to repair and alteration projects. In addition, the impacts on project schedules also appeared to be limited. Three of the 11 projects that encountered unforeseen site conditions experienced schedule delays. These ranged from 23 to 105 days due to the unforeseen site condition.²⁸ For example, in an RWA project to replace power generators at a Social Security Administration center in Maryland, GSA encountered an unidentified masonry wall buried in the ground which interfered with the planned installation of wiring. As a result of this unforeseen condition, GSA issued a contract change order, which, among other things, called for the contractor to remove the wall. The removal added 23 days to the project's schedule. In another project for the Social Security Administration, the existence of conduits in the ceiling that were unexpected led to a 75-day delay in the project schedule. Although only 3 of the 11 projects we reviewed appeared to experience schedule delays based on the records we reviewed, unforeseen site conditions may have caused additional delays. For example, some GSA project managers and contracting officers we interviewed said that extensions due to unforeseen site conditions can sometimes be absorbed into other project delays. As a result, it is not clear how much of a delay, if any, can be attributed to some unforeseen site conditions.

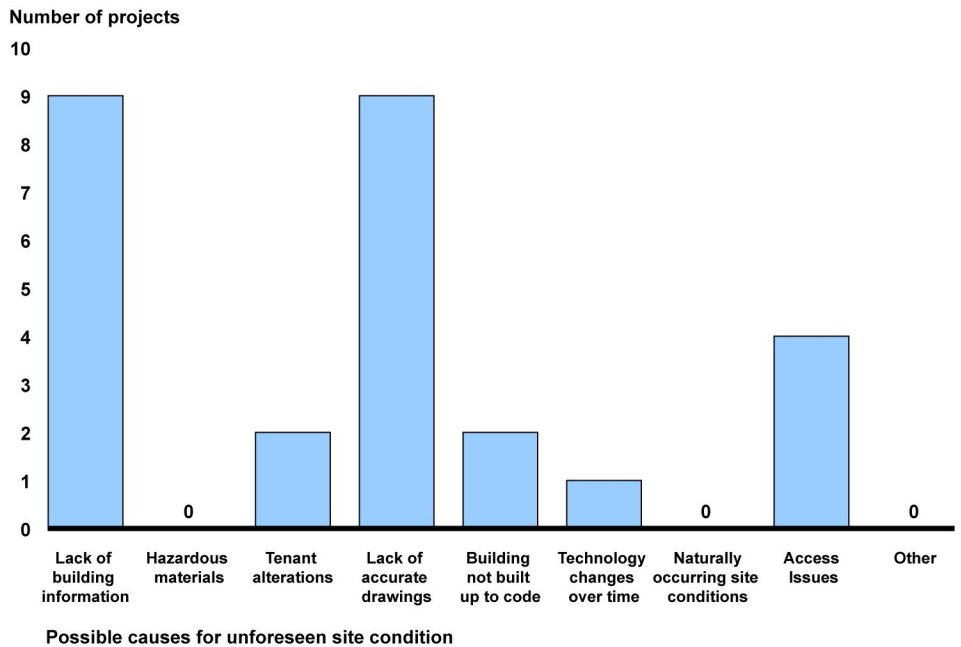
Figure 3: Possible Causes of Unforeseen Site Conditions in the General Services Administration’s Repair and Alteration Projects GAO Reviewed

Note: Hazardous materials, naturally occurring site conditions, and other were not identified as possible causes of unforeseen site conditions on the projects we reviewed. Unforeseen site conditions encountered in the projects we reviewed can have more than one possible cause.

We found that incomplete, inaccurate, or out-of-date building drawings—including as-built, electrical, and mechanical drawings—were the possible cause for the unforeseen site conditions in 9 of the 11 projects we reviewed that encountered unforeseen site conditions.³² For example, in an RWA project to build out a mobile workplace at the headquarters of

In addition, lack of information about buildings was also a top possible cause. For 9 of the 11 projects we reviewed that encountered unforeseen site conditions, the possible cause was lack of information about a building's condition. We defined this category to include unforeseen site conditions that resulted from such things as poor building records, as well as inadequate surveys and testing. For example, one RWA project we reviewed was for the renovation of the U.S. Forest Service Headquarters in Washington, D.C. to allow Forest Service staff to vacate leased space and consolidate in the headquarters building. According to project officials, during demolition, GSA discovered wood subflooring, and that the subflooring lacked fire retardant. Prior to demolition, GSA was not aware of the existence of the wood subflooring, because the wood floor was hidden by carpet. In addition, the building being renovated was built in 1880, and, according to the PMP, original construction documents were not available. In general, project officials said that there was no information available that would lead them to know that wood subflooring existed and that they did not expect to encounter wood subflooring.³³ Remediation of the unforeseen site condition included installation of fire retardant on the floor and installation of a smoke detection system. GSA officials noted this project finished on schedule and within budget and any additional costs or time delays were absorbed by the schedule and budget contingencies.
